SOLON® FLANGE WASHERS SOLVE GASKETED JOINT LEAKS FOR HEAT EXCHANGERS

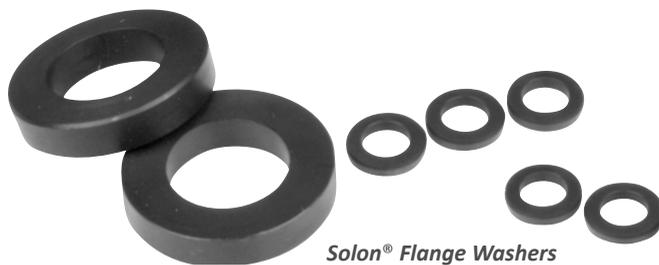
Solon Flange Washers are designed to maintain sufficient bolt tension and resultant gasket pressure in high temperature and high-pressure applications where safety and emission containment take priority.

Solon® Flange Washers were recommended and installed using normal assembly techniques which resolved the gasketed joint leak seamlessly.

There are many variables that occur in a typical flange assembly including; differential thermal expansion, tool inaccuracies, plastic deformation of components, or complex elastic interactions. Mathematical reasoning, laboratory experimentation, and field experience indicate that Belleville spring flange washers are an effective method of creating a more reliable flange assembly.
